Cordova Bay Golf Course Understanding Ecosystems

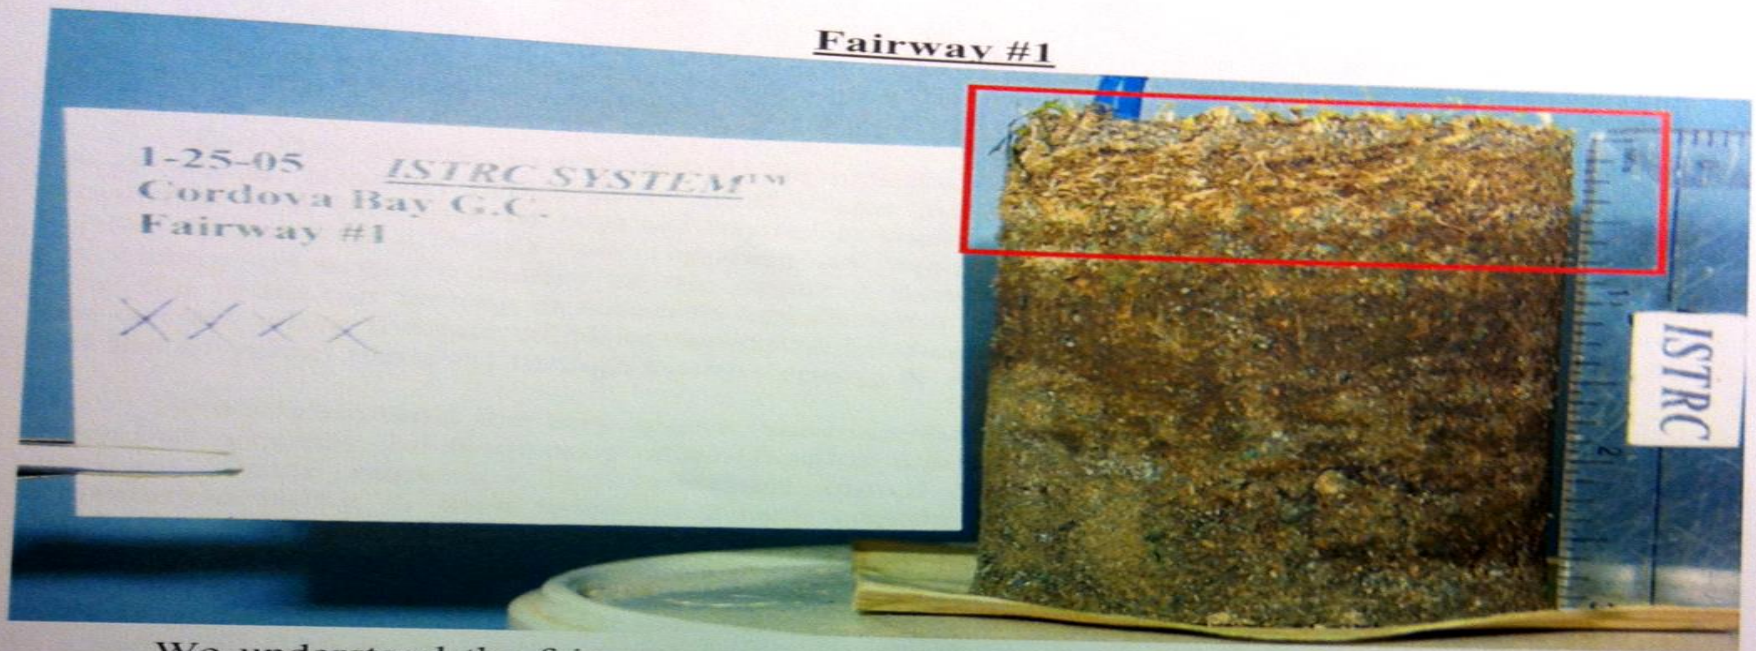
We understand the fairways were capped with 6 inches of sand. Based on the current Textural & Particle Size Analysis the sand at 3 to 4 inches, which is typically indicative of the original root zone material, is extremely coarse. The coarse sand should support accelerated drainage, however given the excessive organic matter & thatch in the upper 3 inches the fairways are essentially sealed off. As with the greens, our general recommendation would be to implement an aggressive cultural program with an emphasis on displacing the existing material with a good quality topdressing sand.

Fairway #1	ISTRC Target Ranges Poorly Drained Fairways
Infiltration Rate [In/hr]	0.00 [sealed off – reflects a dense thatch layer and a high percentage of organic matter within the upper 3 inches]	At least 2
Subsurface Air Capacity [Non-Capillary Porosity]	8.86% [low]	At least 12%
Water Porosity [Capillary]	52.14% [extremely high – demonstrates the need for aggressive aerification, verti-cutting, and topdressing in the fairways]	Less than 30%
Bulk Density [g/cc]	0.99 [extremely low – the low bulk density coupled with a total porosity in excess of 60% is a classic indicator of a thatchy root zone that is soft with excess water retention]	1.35 to 1.45
Water Holding	52.55% [extremely high]	Less than 25%
Organic Content – ¼ to 1"	5.11% [extremely high]	1.5% to 3.0%
Organic Content – 1 to 2"	3.39% [high]	1.0% to 2.0%
Organic Content – 2 to 3"	2.99% [high]	0.5% to 2.0%
Organic Content – 3 to 4"	0.77% [ok]	0.5% to 2.0%

Root Mass	½ in.	at least ½ in.
Feeder Roots	3 in. sparse	at least 3.5 in. –med. density
