Worst-case scenario

Maintaining a course in the flood plain means always being ready for disaster.

Michael Brandon

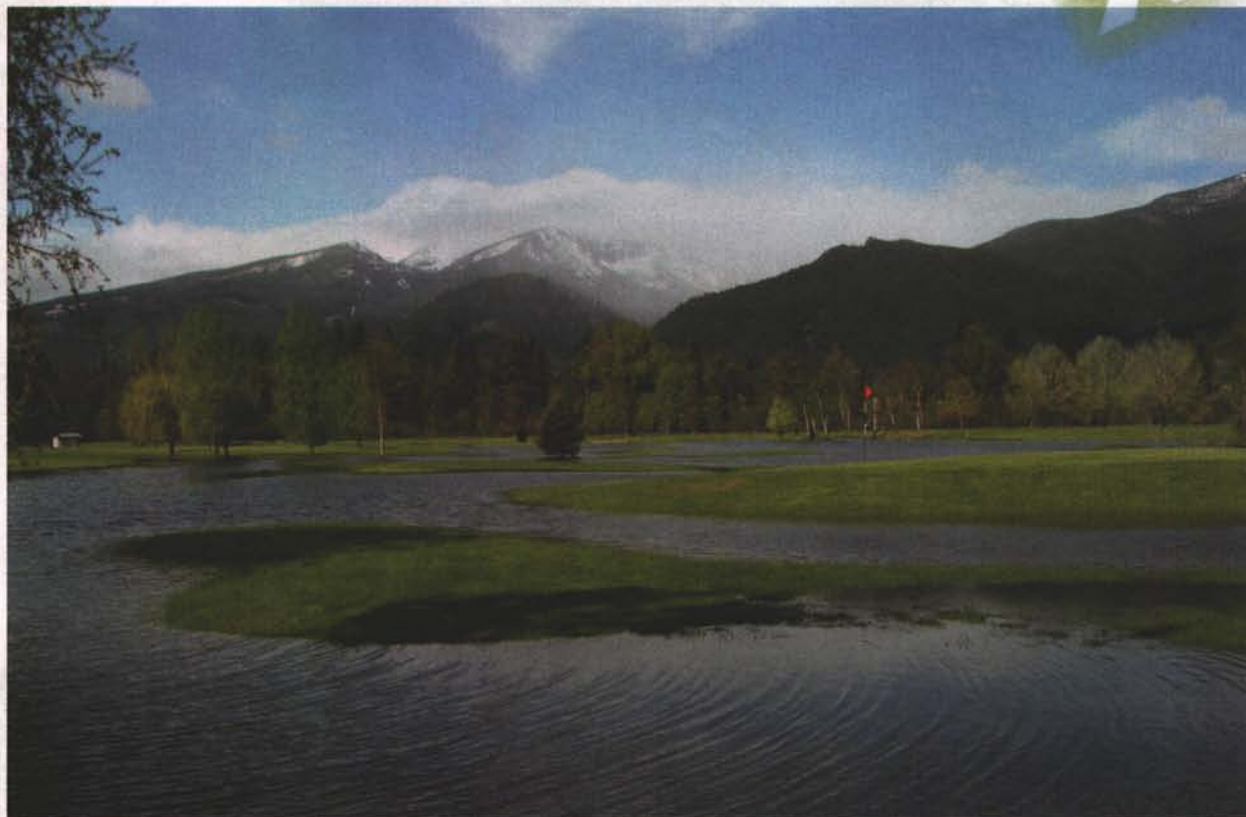
No. 2 at White Tail Golf Course after a minor flood. During more significant floods, No. 2 would be completely inaccessible, with only the flagstick being above water. Photos by Maggie Brandon

The golf course typically doesn't handle any significant rainfall well, largely because of its water table level. There is simply nowhere for the water to go. On the northeast end of the No. 2 fairway, the water table can be reached with one turn of a shovel. The importance of drainage on a golf course cannot be overstated, but in the case of WTGC, the golf course *is* the drainage.

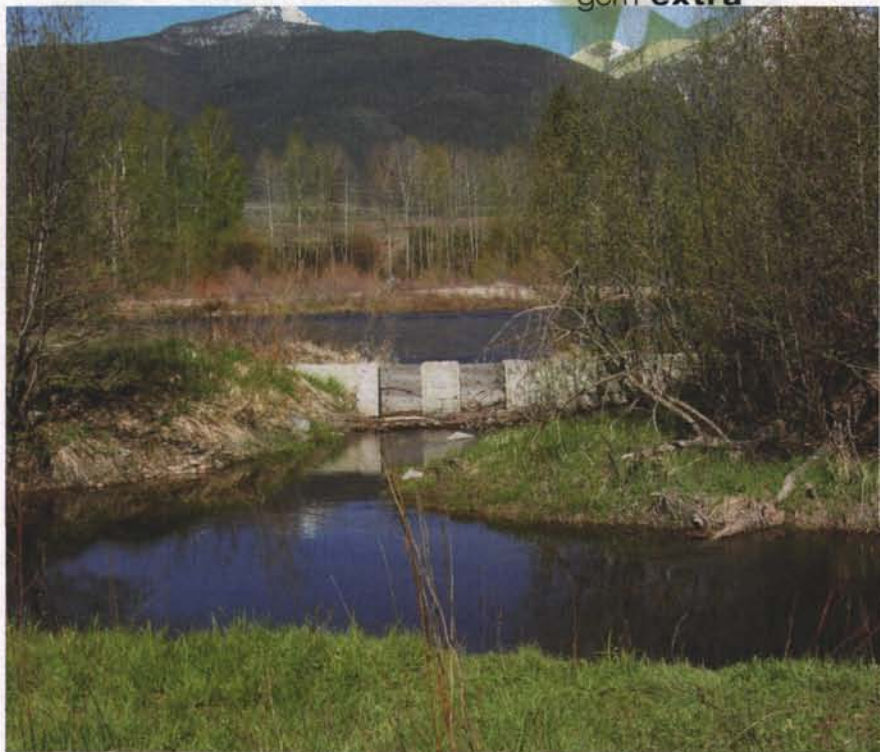
Above left: Michael Brandon, Class A superintendent at White Tail Golf Course. **Above:** A weir that divides the Bitterroot River and Middle Burnt Fork Creek. The weir is no longer functional and water spills over it during severe floods.

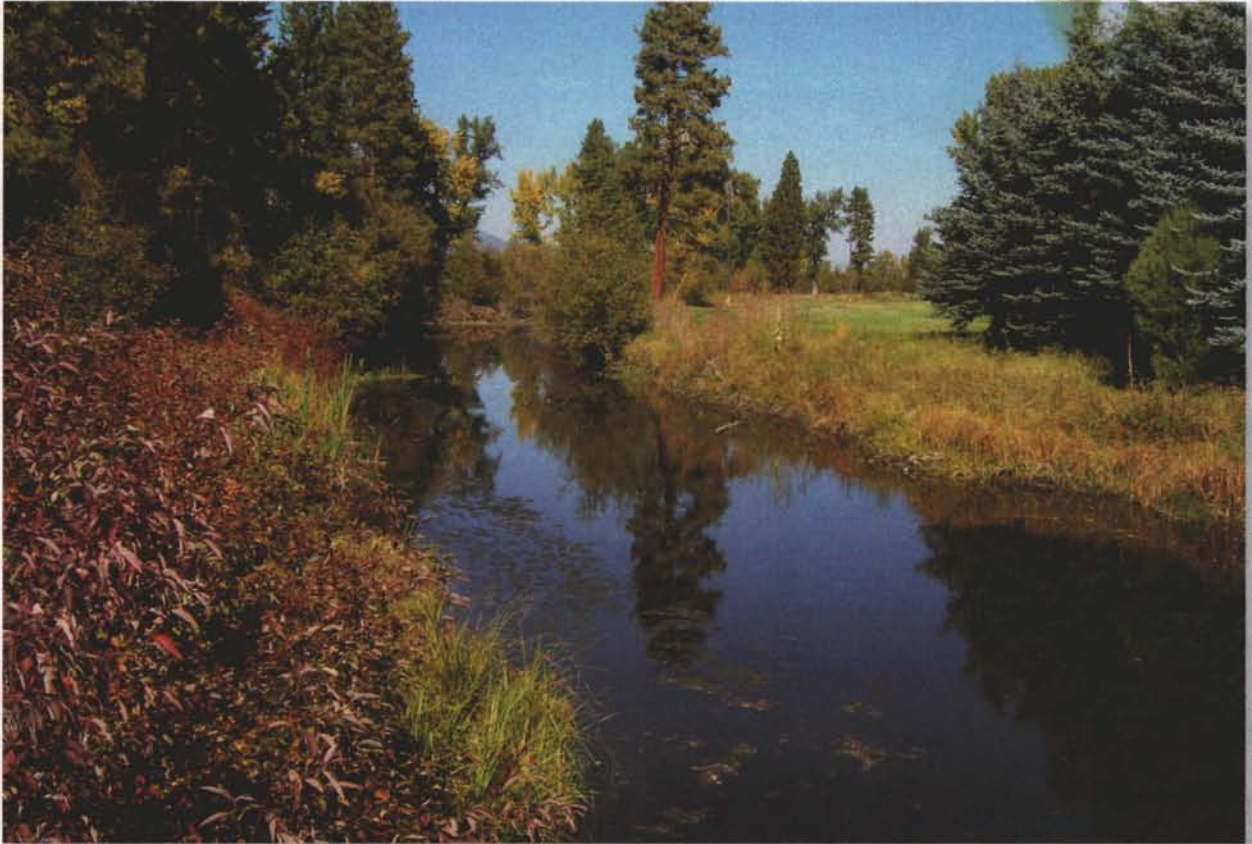
Middle Burnt Fork Creek lies dangerously close to White Tail Golf Course. In the background, No. 7 fairway is visible.

While I was making my way around the course attempting to keep the greens mowed as best I could, I noticed that the footbridge that spans Middle Burnt Fork Creek to No. 7 tee was tipping at a precarious angle and being pummeled by the incessant torrent. I feared we would lose the bridge completely before the water finally crested. Middle Burnt Fork Creek runs parallel to the Bitterroot River between the refuge and the golf course. Of course, now it was indiscernible from the river.

As the water table continued to drop, the vegetation in the refuge and on the golf course began to appear and the smell of rotting flora was rife. As Middle Burnt Fork Creek continued its steady withdrawal back to the confines of its banks, we were finally allowed to closely survey the damage the high waters had done to our footbridge.

The 1,500-pound concrete footing that had once anchored the bridge now lay uselessly 10 yards downstream in the middle of the creek, giving testament to the sheer power of water and erosion. The bridge, amazingly, was still clinging precariously to the eastern footing, pointing downstream along the muddy bank. Its structural integrity had been utterly compromised. It was obvious that it would not be a matter of salvage, but an issue of removal and replacement.
